NATIONAL AERONAUTICS AND SPACE ADMINISTRATION

APOLLO 10 MISSION REPORT

MANNED SPACECRAFT CENTER

AUGUST 1969

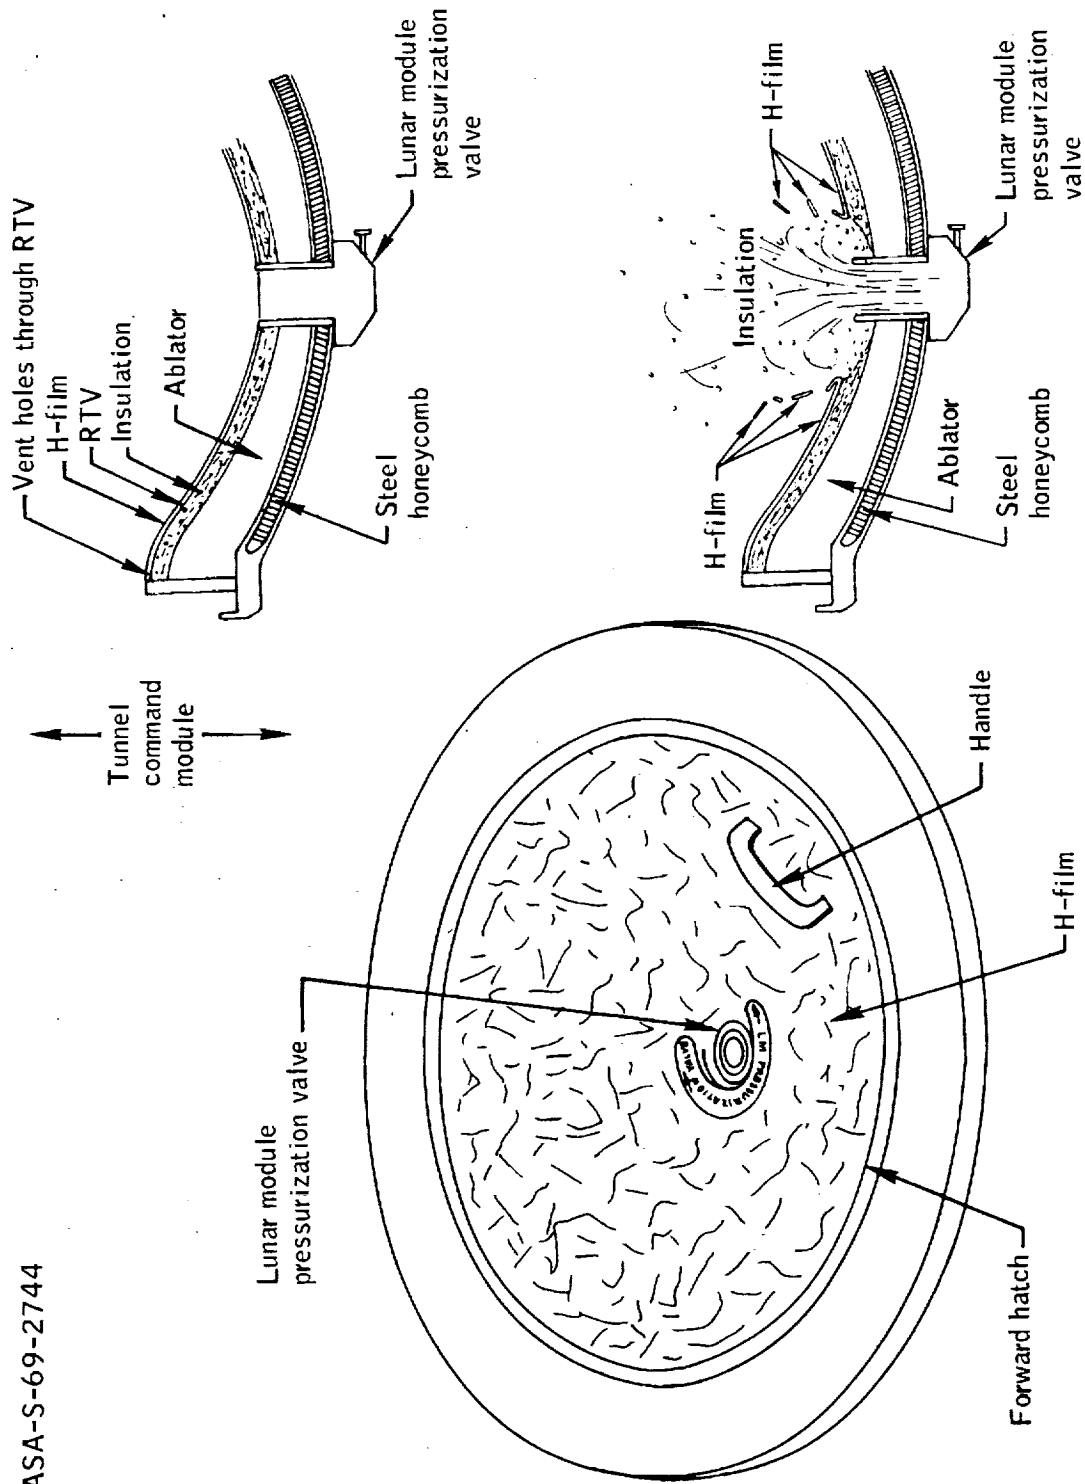
Figure 15-16.- Forward hatch thermal coating.

Some insulation on the forward hatch was blown loose during tunnel pressurization, and particles were dispersed throughout the cabin. No insulation remained after entry. This problem is discussed in section 15.1.17.

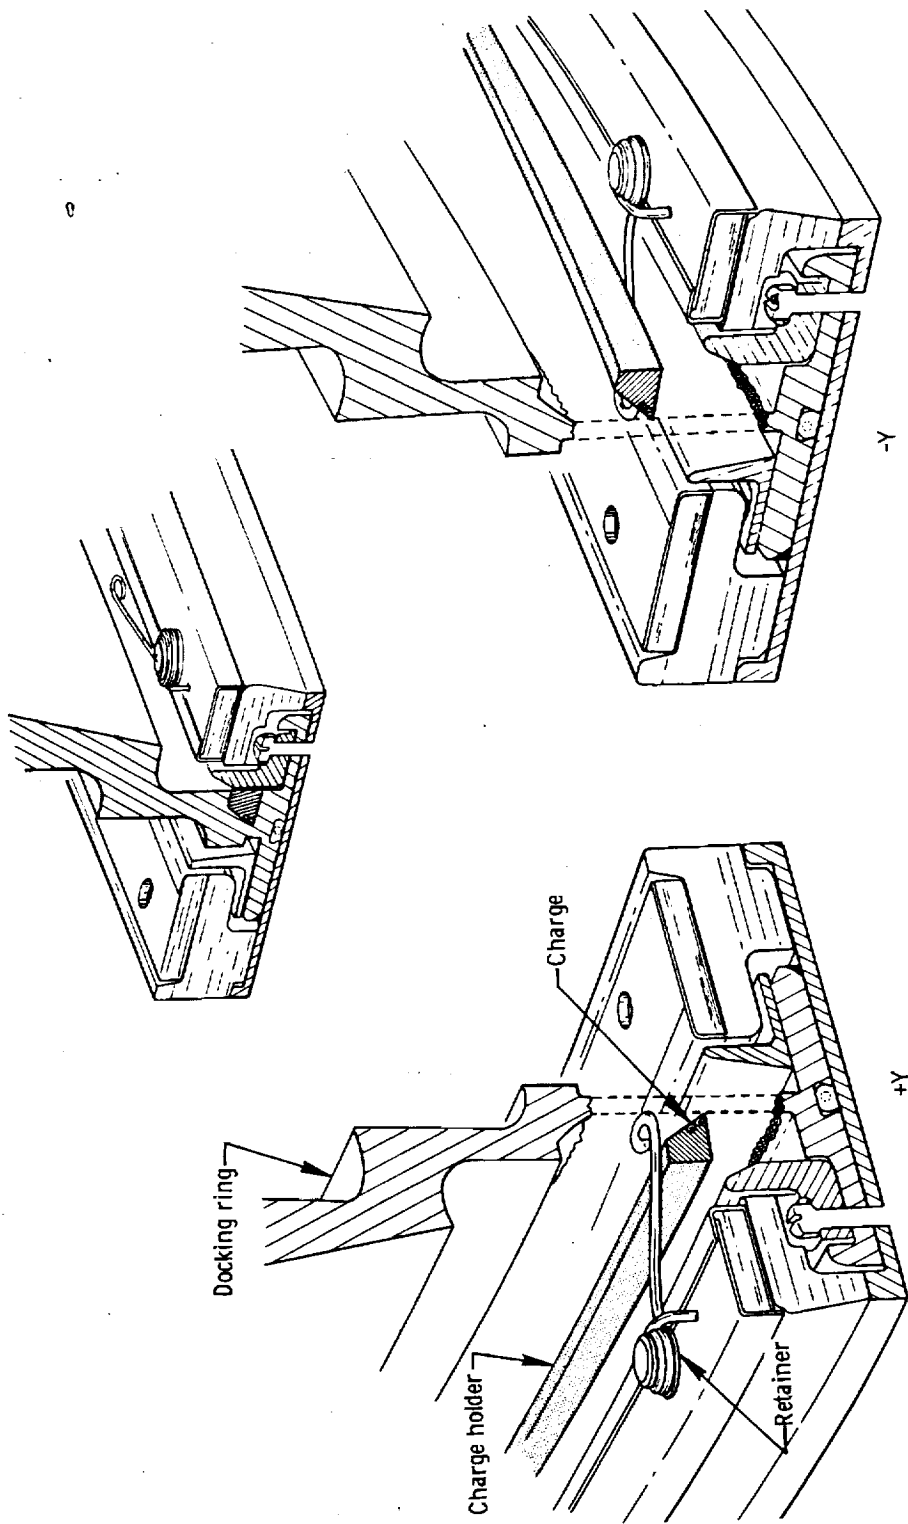
Figure 15-19. - Charge holder retention.

Four retaining springs were added on Apollo 10 to contain the docking-ring pyrotechnic charge holder following lunar module jettison. The two springs on the minus Y side failed to capture the charge holder. This is discussed further in section 15.1.20.
